## Residential Home Stucco Rehabilitation Tarpon Springs, FL

### DRYLOK® Extreme Performs a “Stucco Rescue”

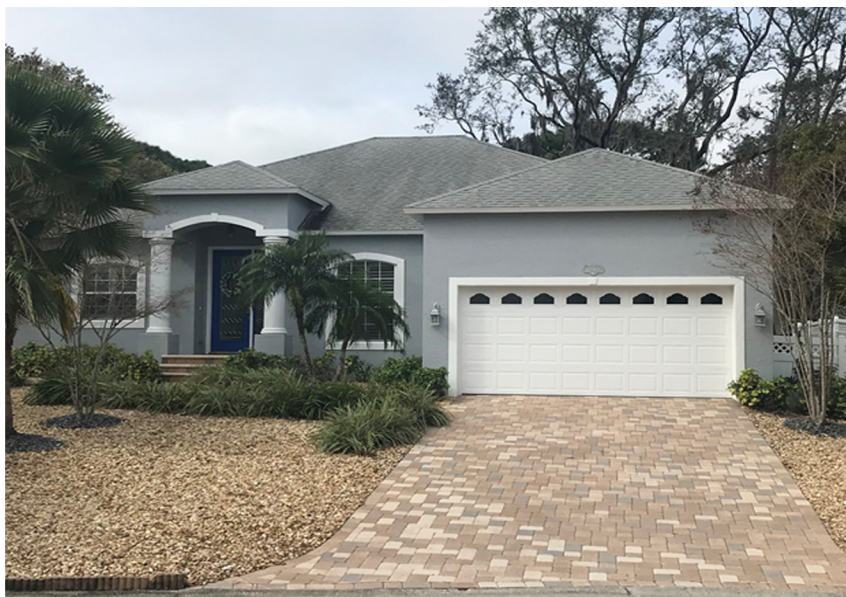
But, what if your builder failed to provide you a DRYLOK barrier coating, and your structure has gone beyond the limits of its original ordinary paint coat? It was the unfortunate dilemma facing a homeowner in Tarpon Springs, Florida. The stucco surface had cracked so severely because of the lack of protection that the homeowner potentially faced a complete removal of the exterior skin of their home.

“When my team began to use the DRYLOK EXTREME, they noticed it was thicker than other products they had installed before,” commented Dennis. “We sprayed and back-rolled the DRYLOK to the recommended mil thickness and were amazed that the product filled and sealed the cracks, saving us an immense amount of time filling each individual crack with a caulking compound and having noticeable fill lines.”

Upon the application of the second coat of DRYLOK EXTREME, the cracks were all filled and virtually invisible.
