CASE STUDY | PROFESSIONAL

BREVARD COUNTY COURTHOUSE

VIERA, FLORIDA

DRYLOK® MASONRY WATERPROOFER

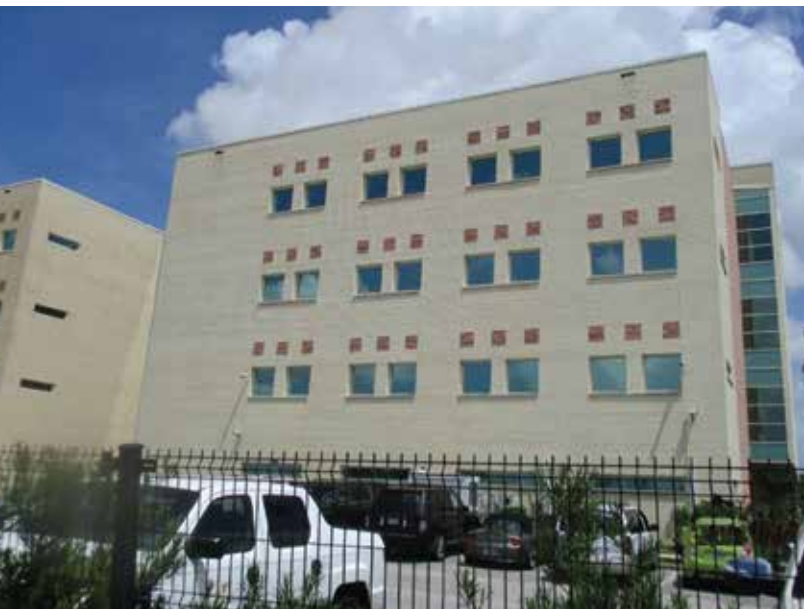
This 4-story addition, housing courtrooms and judges' chambers, was completed in 2009.

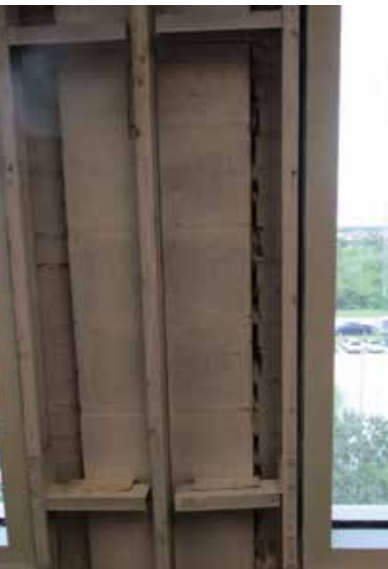
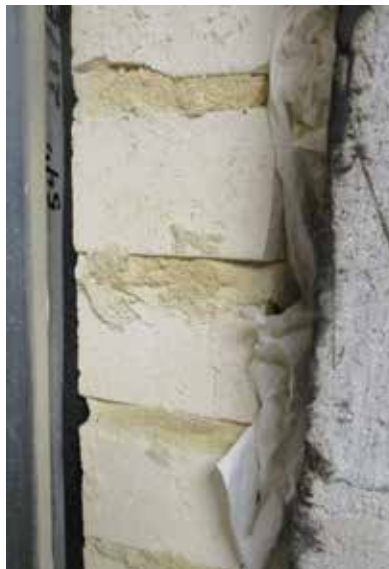
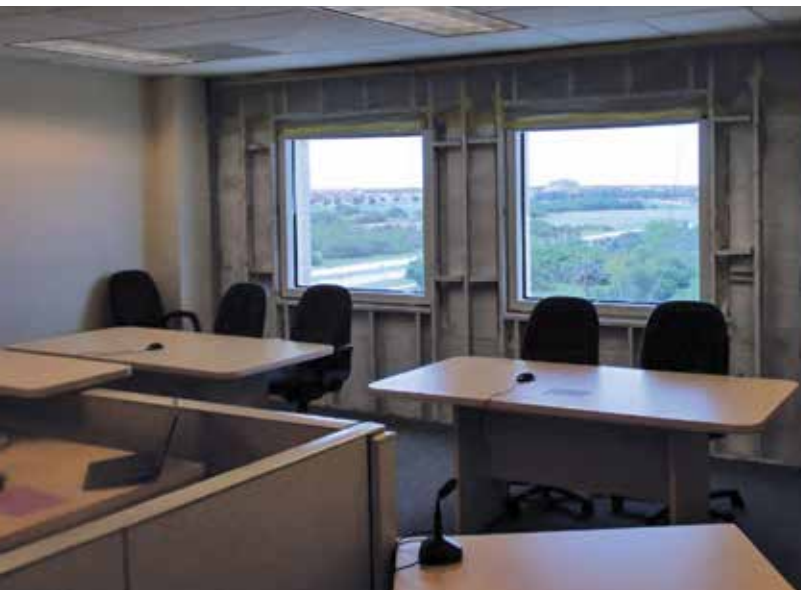
When moisture was found to have damaged interior gypsum board in the Brevard County Courthouse, an occupied public structure, they needed a fast, easy to use, cost-effective solution that wouldn't require significant exterior renovation. Visible water damage and mold on the gypsum board inside the building indicated previous water intrusion.

How did it get there? An existing, negative internal pressurization of the structure, aggravated by strong, coastal, wind-driven rain and seasonal hurricanes, was responsible.

It had pushed moisture through the gaps between concrete masonry unit (CMU) block columns that had been poorly tied into the face brick returns at the window openings, and caused condensation on the interior steel gypsum board studs.

Prior to patching and waterproofing, the negative pressurization issues were solved. Then, a mockup section was repaired with DRYLOK® products and tested by the project consultants. A professional-grade, high-pressure spray rig was used to simulate wind-driven rain conditions. After the repair passed the rigorous tests, renovations were completed within a few short weeks with the courtrooms and judges' chambers restored to their original interior finish condition. The process included these 3 steps:

Step 1: DRYLOK® Concrete Patch and DRYLOK® Fast Plug®, a fast-setting hydraulic cement, were used to fill the gaps between the returned face brick and the interior concrete columns (negative side) of the building exterior walls on the third and fourth floors. These products were chosen because of their excellent masonry-to-masonry adhesion, and because DRYLOK® Fast Plug® doesn't shrink after drying. Due to time constraints, the speedy set time was an important factor. Backer rods were inserted into the deeper gaps and filled with DRYLOK® Concrete Patch.

Step 2: To seal the patching materials and create a long-term barrier against both casual moisture and wind-driven rain intrusion, two coats of DRYLOK® Extreme Masonry Waterproofer were applied on the interior side of the walls, over the patches, and around the windows. Since speed was critical, the product's Green Wise® certification, low VOCs, and low odor formula meant less time worrying about delays related to airing the structure.

Step 3: Finally, to add another layer of protection, DRYLOK® Water-Base 5% Silicone Brick and Masonry Sealer was applied to the exterior brick facing. This durable, clear, water-repellent coating helps prevent water from getting into masonry in the first place, while allowing water vapor to escape. Since then, this product has been reformulated to deliver even better performance under its new name, DRYLOK® Siloxane 7 Brick & Masonry Penetrating Sealer.
